## APPENDIX – 2009 Field Inspection Summaries

Utility: **ComEd** Investigators: **John Stutsman (Staff)**  
Feeder Ckt: **S431** City: **Odell** Voltage: **4/12kV** Date: **Monday, September 21, 2009**

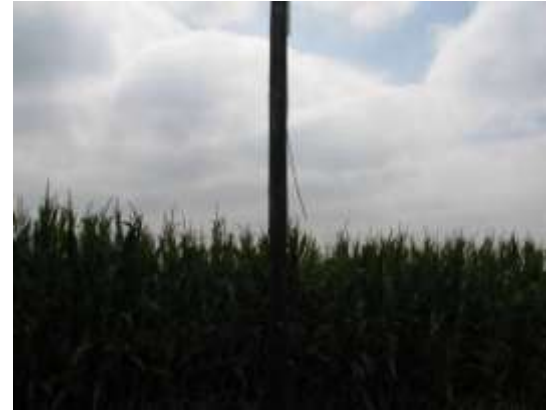
Ground wire cut at approx 7 ft up pole

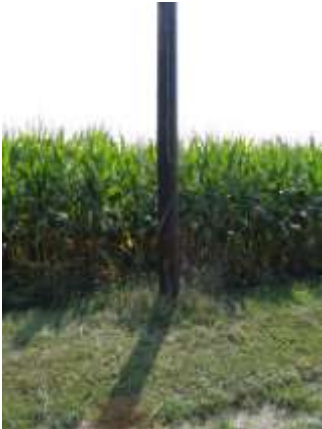
Conduit cut to remove ground wire

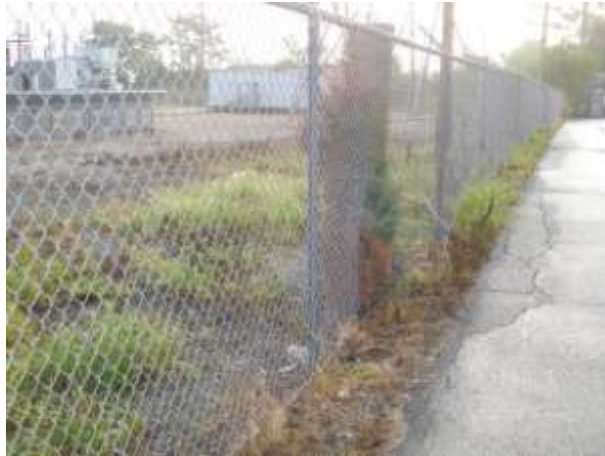
Dist Gear fence & more weeds/vines in Substation yard

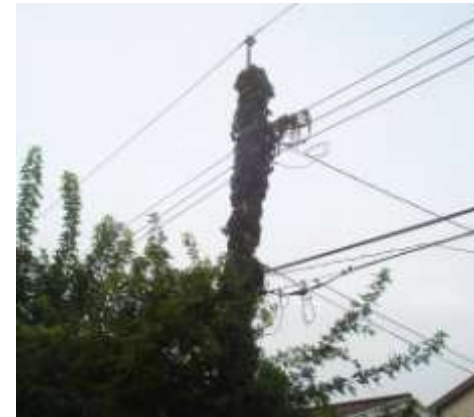
Vine growing on pole but not yet into Primary

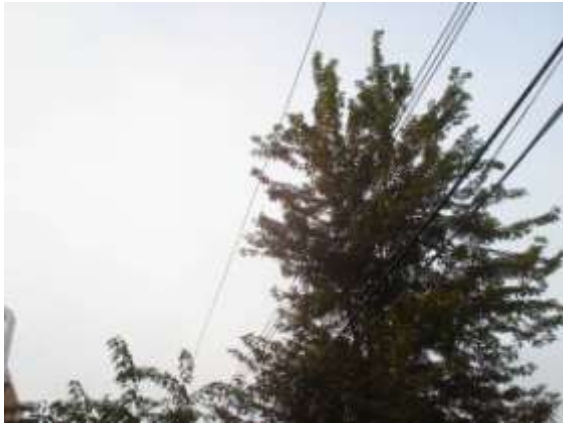
Tree near Primary

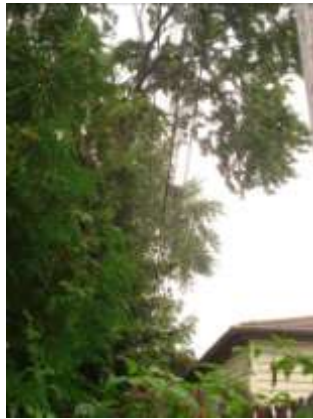
Primary into tree & heavy overhang

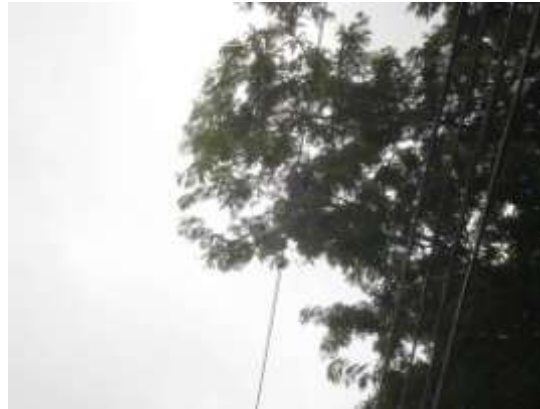
Tree into Primary

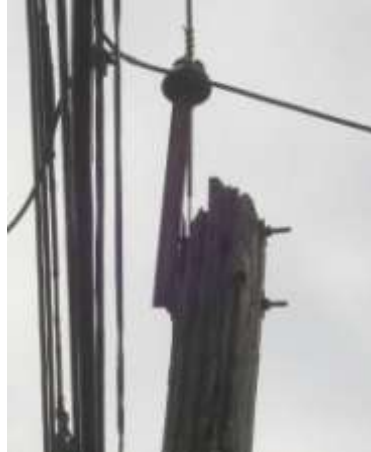
Bad Pole Top

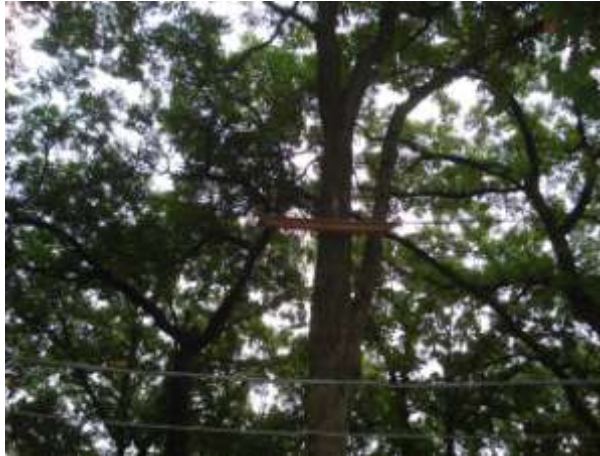
Line hose protecting Primary against tree

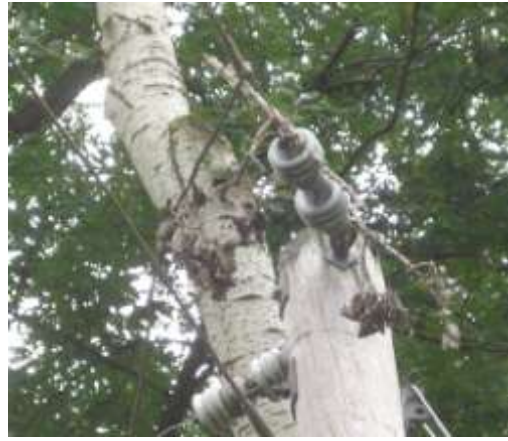
branch on primary

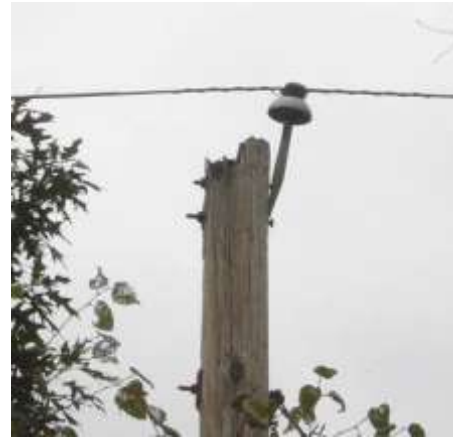
Bad pole top lose hardware

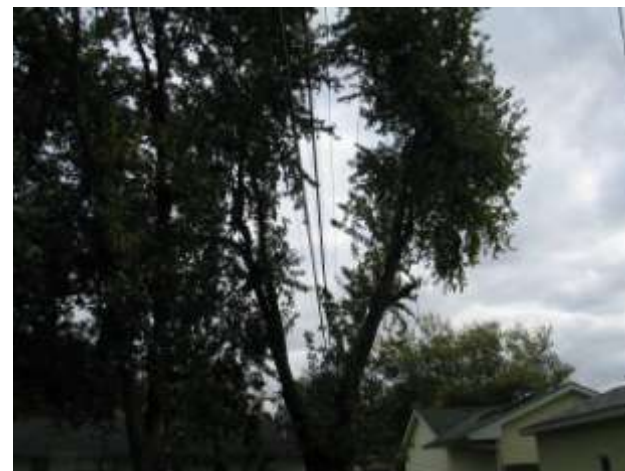
Silver Maple & Primary

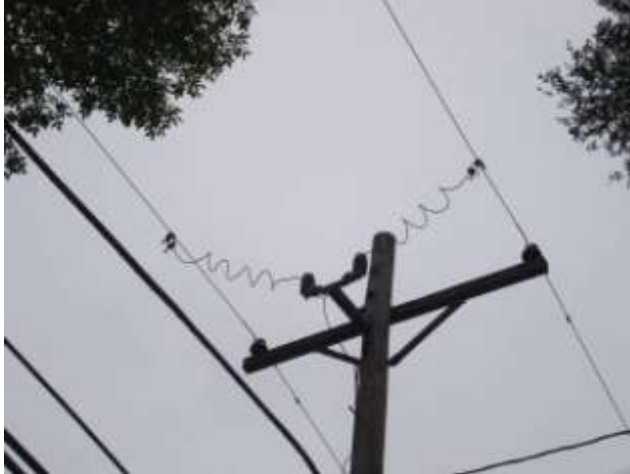
From TSS150 the inspection continued to circuit Z15093 where the following was observed: bad pole tops; a blown lightning arrestor; loose hardware; Primary into tree; Jumpers from Primary to a Lightning arrestor were coiled – coiled jumpers introduce high impedance to high frequency current flows –reducing the effectiveness of the lightning arrestor.

Coiled jumpers to lightning arrester

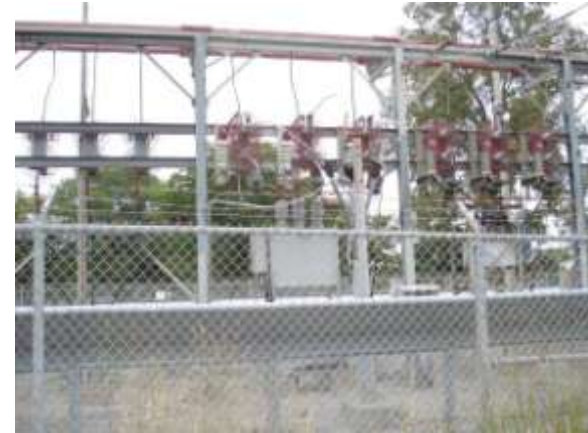
animal protection visible on equipment

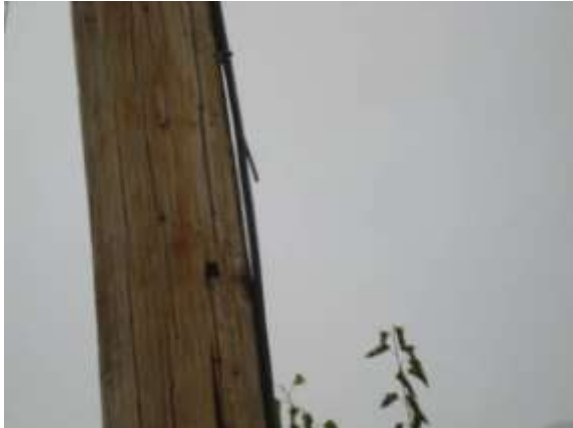
From TDC458 the inspection continued to circuit G588 where the following was observed: about 10-12 feet of ground wire had been cut and stolen; part of a cross-arm had rotted out causing a pin supporting a Primary insulator to lean; branch on cross-arm and Primary.

Ground wire cut and stolen from guard

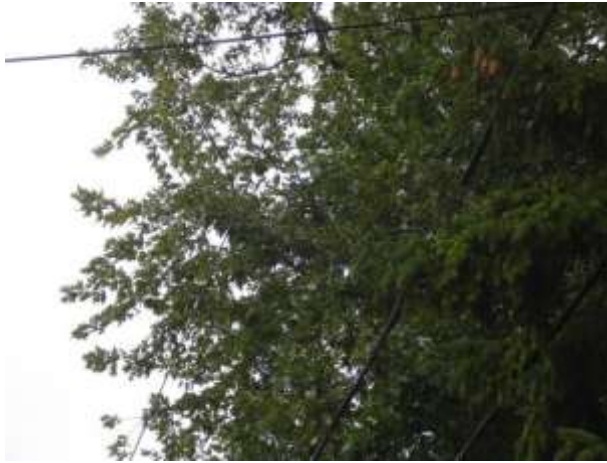
Silver Maple into Primary

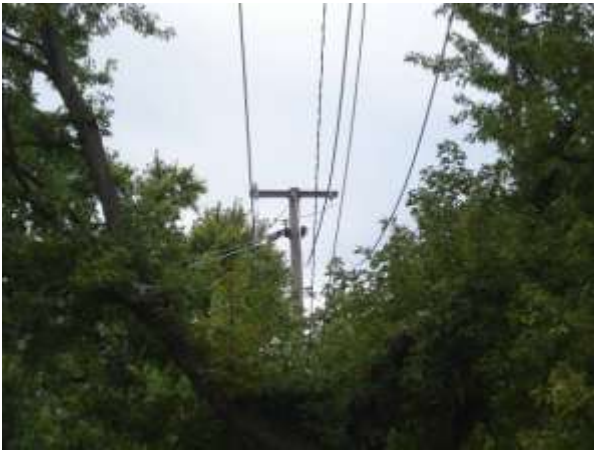
Trees into Primary

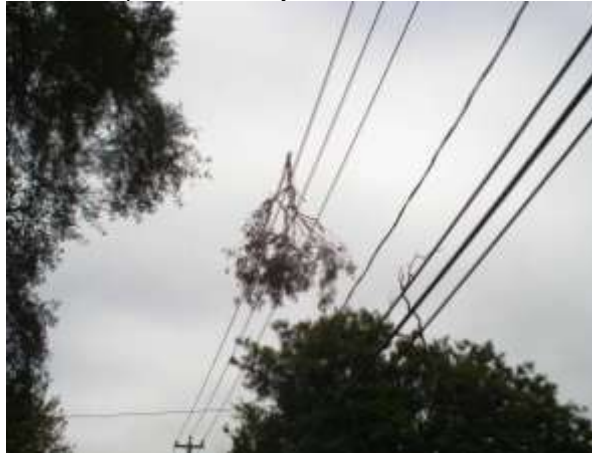
Branch on Primary

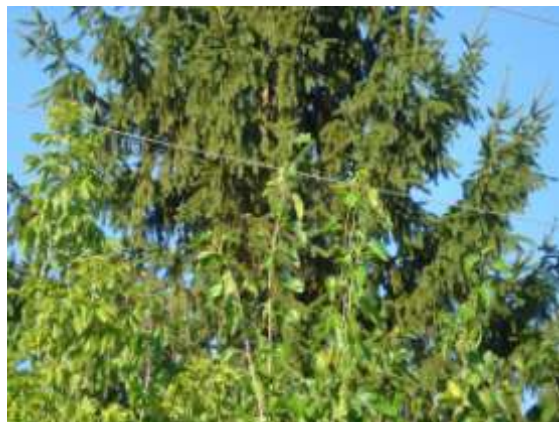
Trees into primary

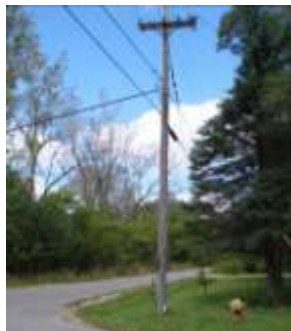
Broken Guy wire wrapped around pole

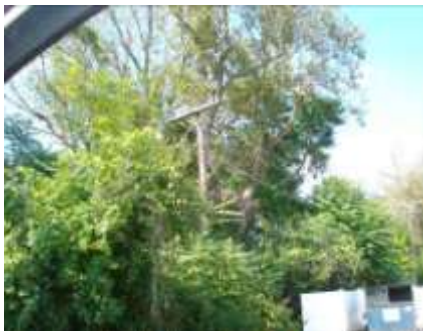
Vines on pole & lightning arrestor

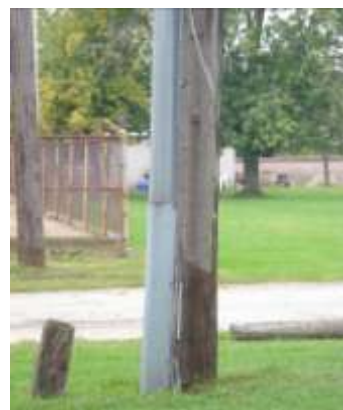
NESC 215(C)(1) Compliance Issue

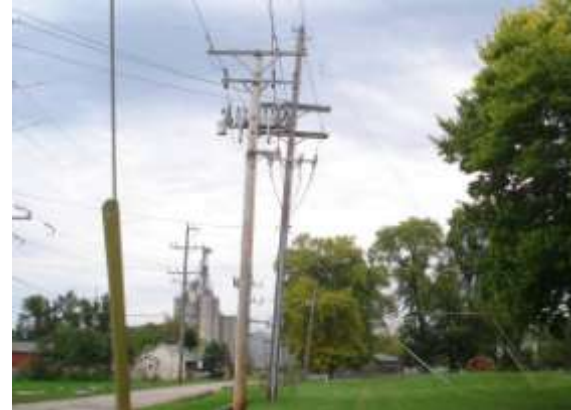
NESC 279 Compliance Issue

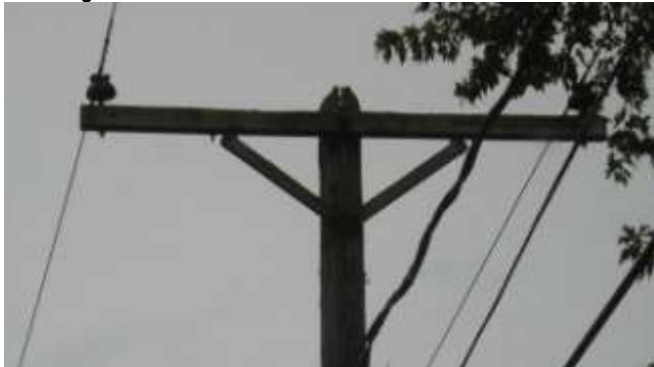
4.1 Bad Pole Top

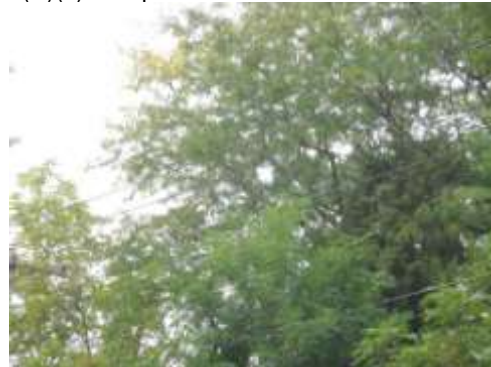
Tree into Primary

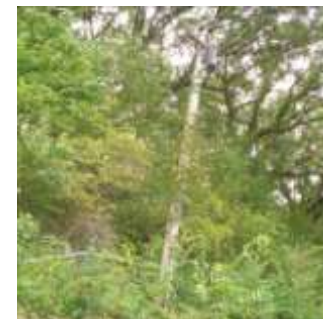
Vine on pole & into secondary cable guard

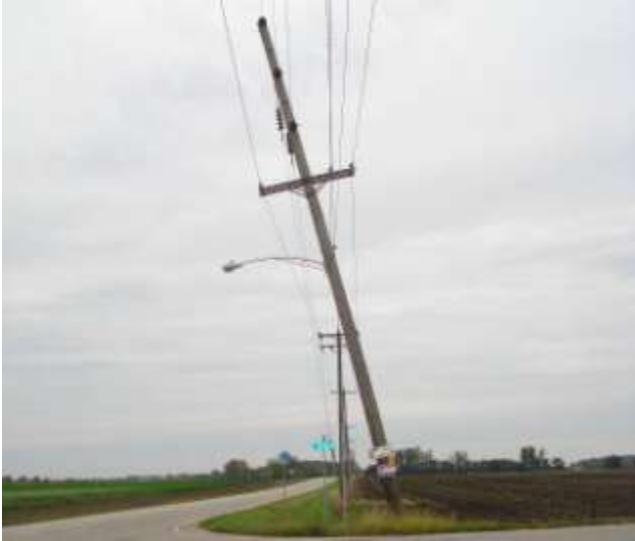
NESC 279 Compliance Issue & Badly leaning pole

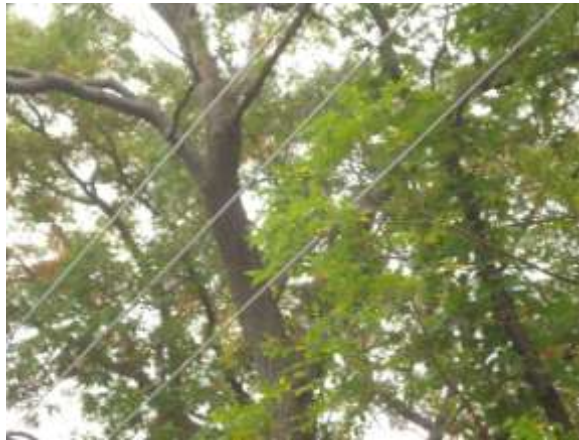
Tree contact with Primary

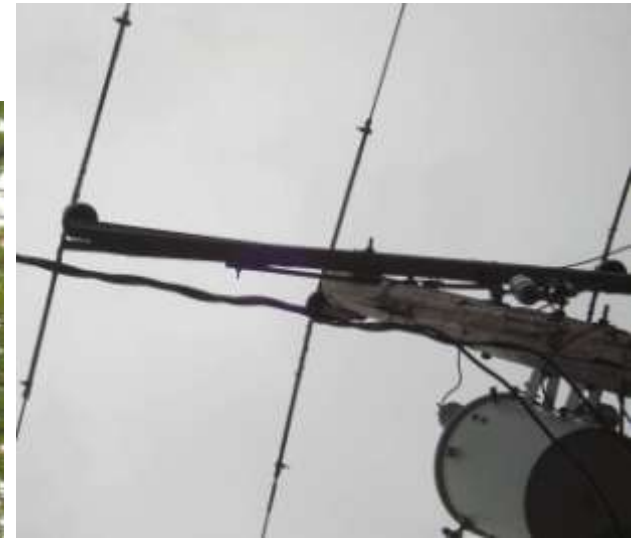
Split Cross-arm

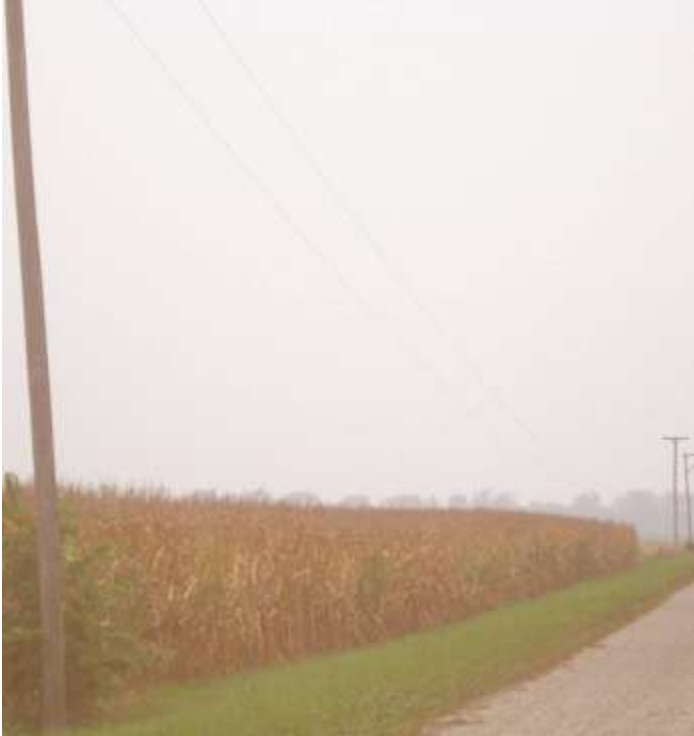
Clearance issue with Primary too low

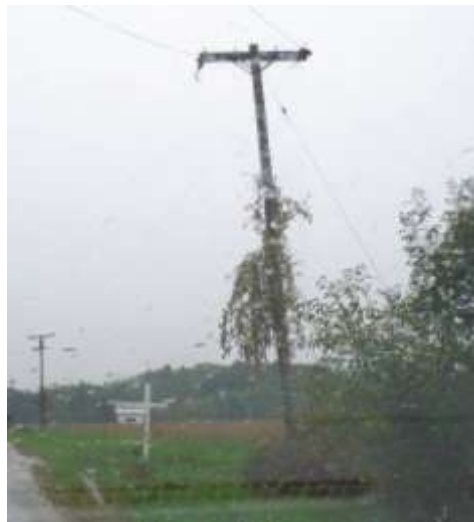
Vines on pole

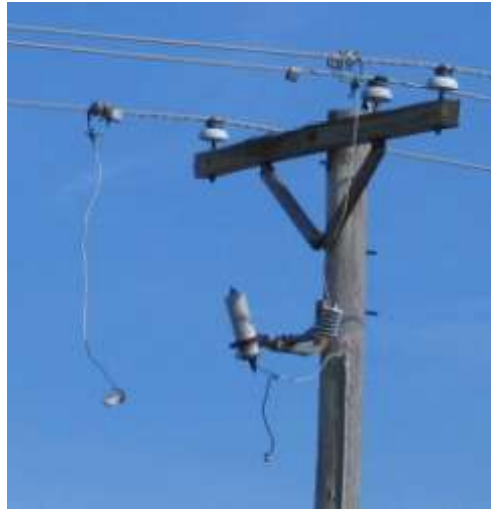
Blown lightning arrestor

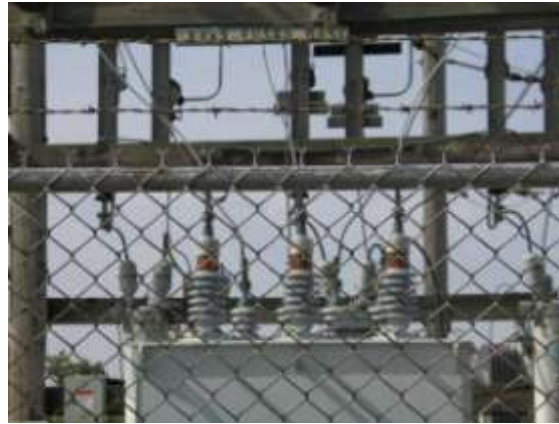
Bushing Oil levels – C phase on left

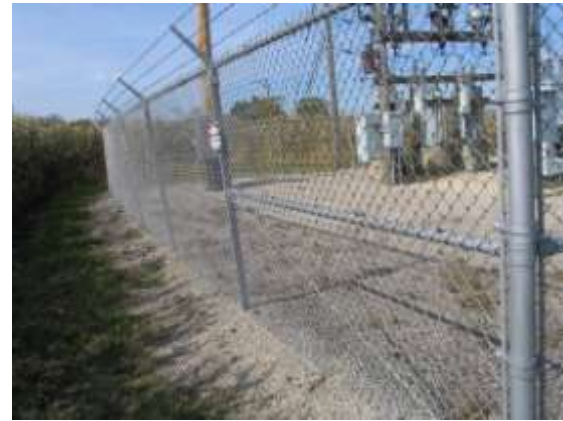
Area clear around substation fence

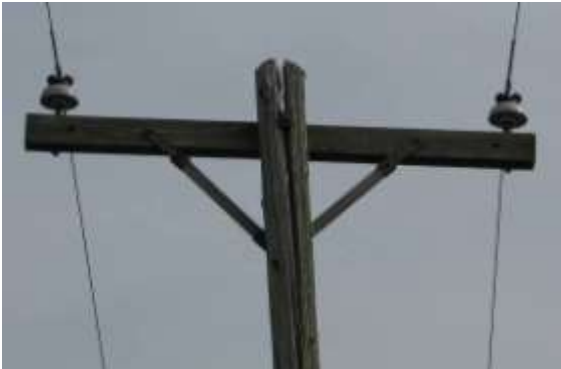
Split pole top

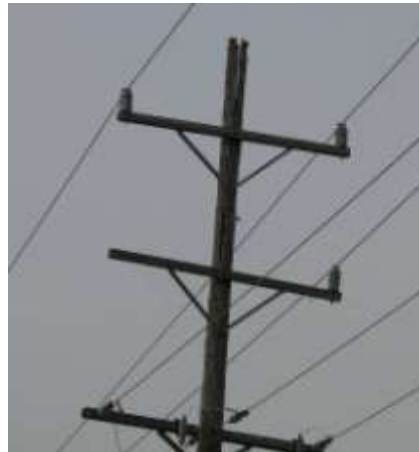
Split pole top

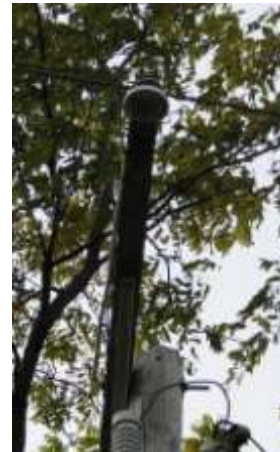
Ground molding loose

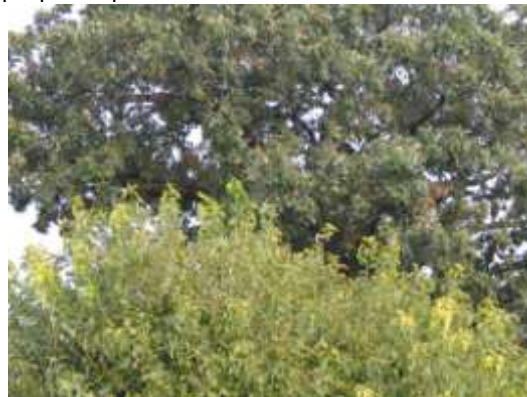
Primary into tree

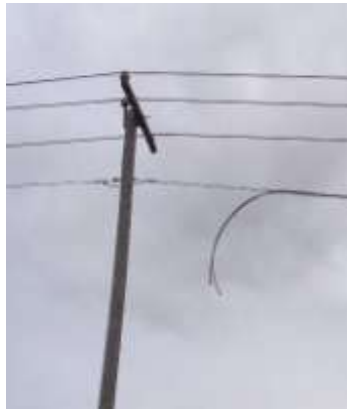
Secondary taped and hanging

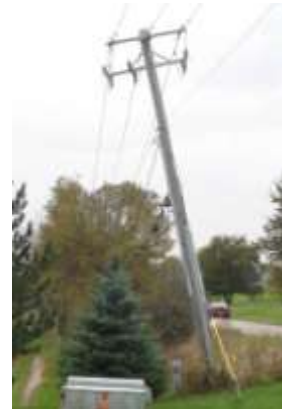
leaning pole – note evergreens planted under Primary

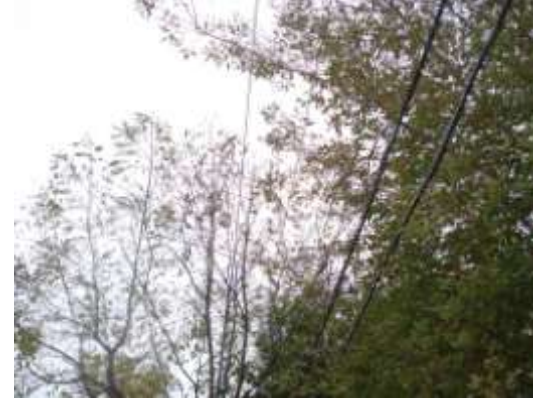
Branches in primary

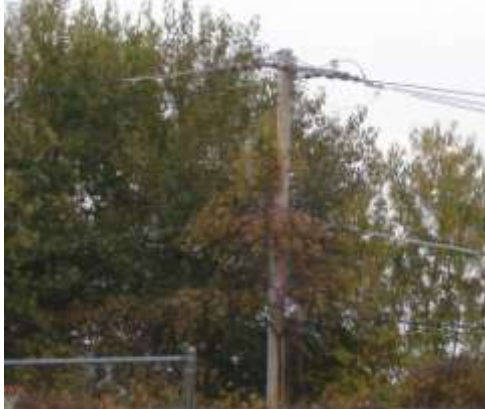
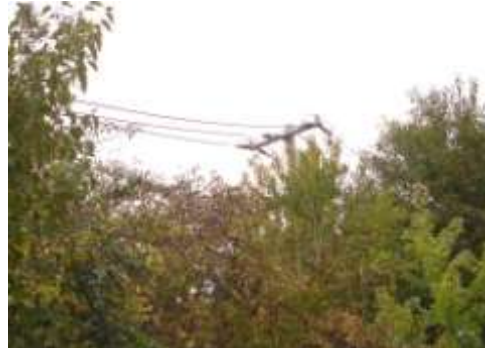
Overgrowth on Transformer -- view from West & view from East

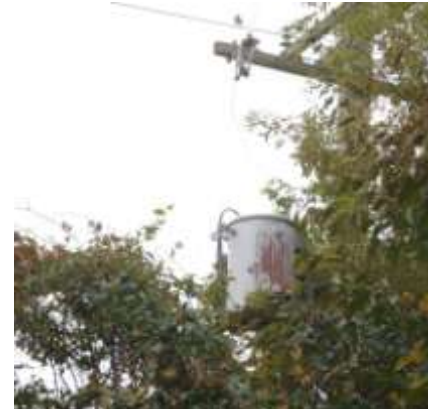
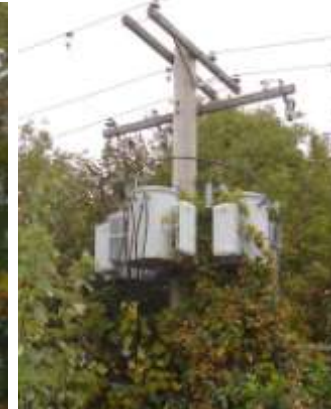
Overgrowth on 3-bank Transformer – North view & South view

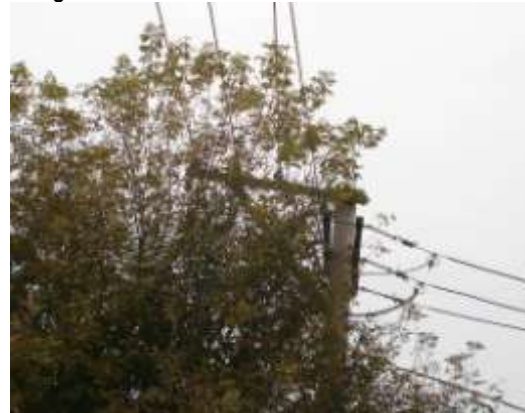
Branches close to primary

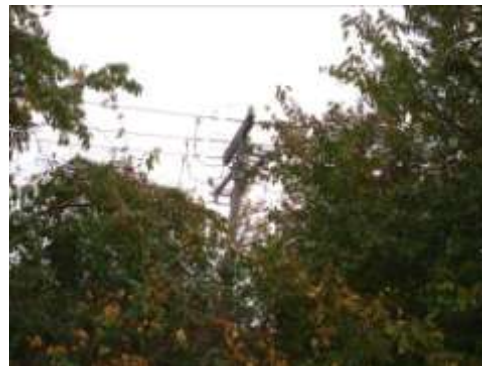
Vines growing into device

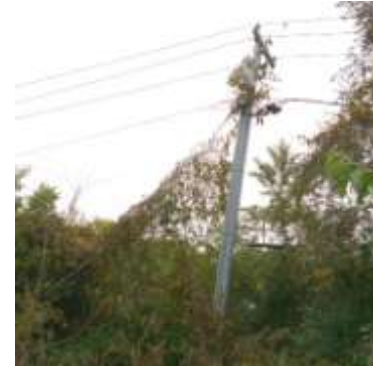
Vines growing up-to/onto transformer

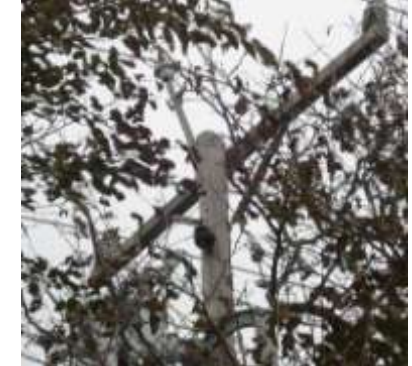
Bent insulator mount

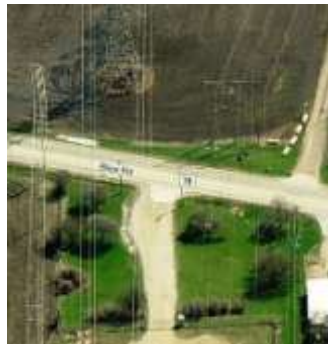
Aerial view of ROW before Trees were removed

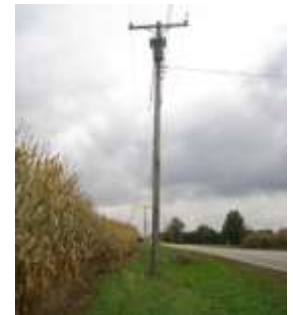
Loose/slack guy wire

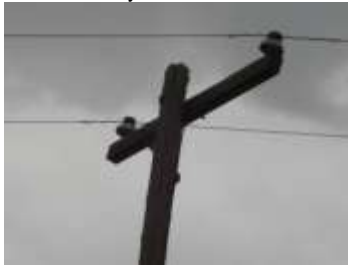
Twisted cross-arm

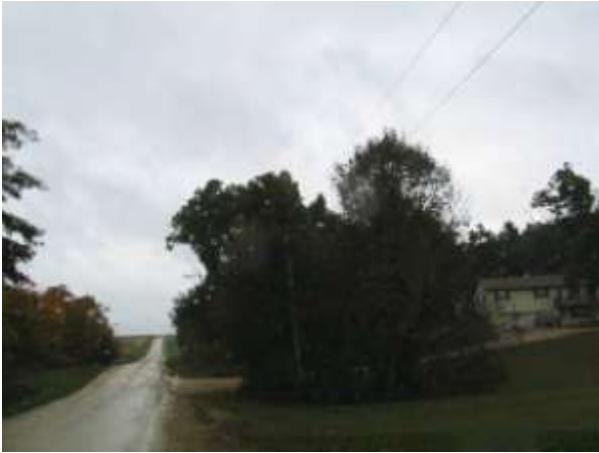
Trees close/in primary

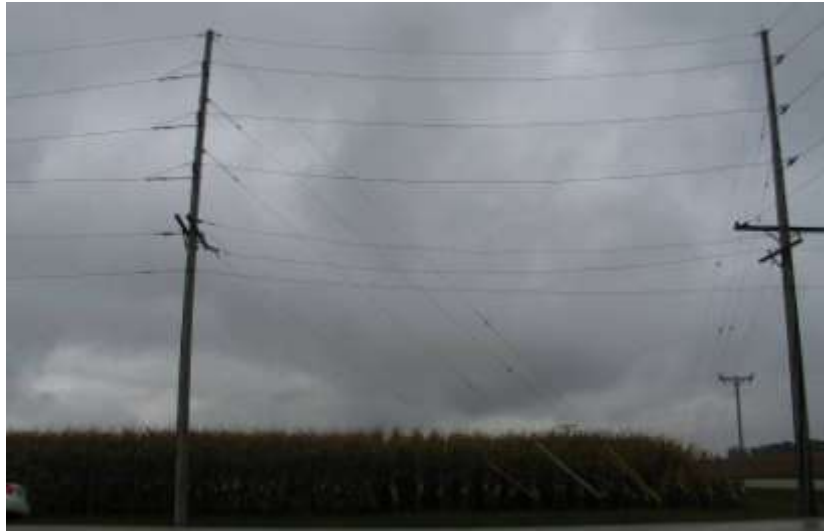
<sup>2</sup> Illinois Administrative Code 305 was revised to adopt the 2002 NESC on June 15, 2003. Rule 279(A)(2)(b)(1) states: "All insulators shall be located at a position that maintains the bottom of the insulator not less than 2.45 m (8 ft) above the ground if the guy is broken below the insulator." Before 2003 the requirements for insulating guys had been unchanged (except for changes in the relevant Rule numbers) since the adoption on October 1, 1984 of the 1981 NESC which stated in Rule 283(B)(2) "Insulators shall be installed as follows: (a) All insulators shall be located at least 8 feet above the ground. (b) Where hazard would exist with one insulator, two or more guy insulators shall be placed so as to include, in so far as is practical, the exposed section of the guy between them. (c) Insulators shall be so placed that in case any guy sags down upon another, the insulators will not become ineffective." Before 1984 the requirement that guy insulators be at least 8 feet above the ground goes as far back as General Order 30 adopted by the Commission in October 1916. The requirement that "insulators shall be so placed that in case any guy sags down upon another the insulators will not become ineffective" dates back to General Order 115 that became effective in August 1927.

NESC 279 issue with 2 bottom guy wires for overbuilt

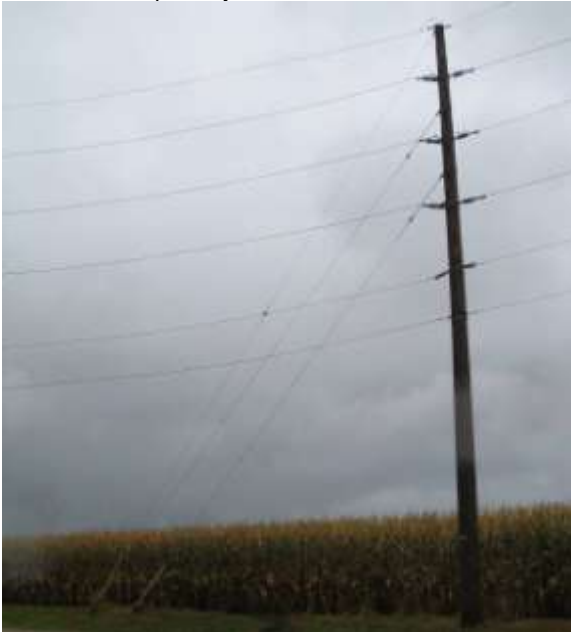
NESC 279 compliance issue

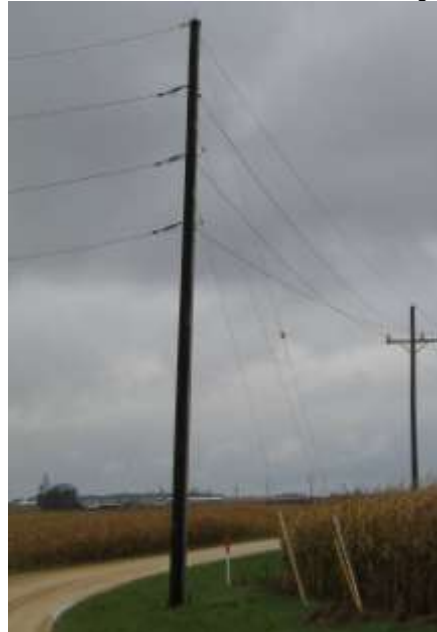
NESC 279 compliance issue

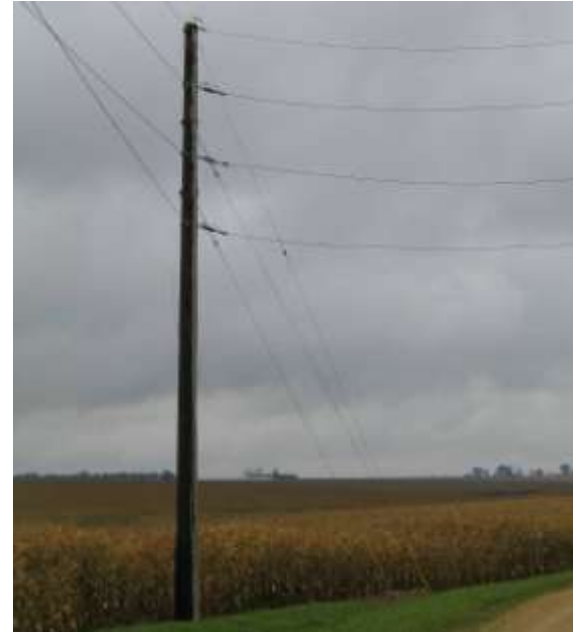
NESC 279 compliance issue

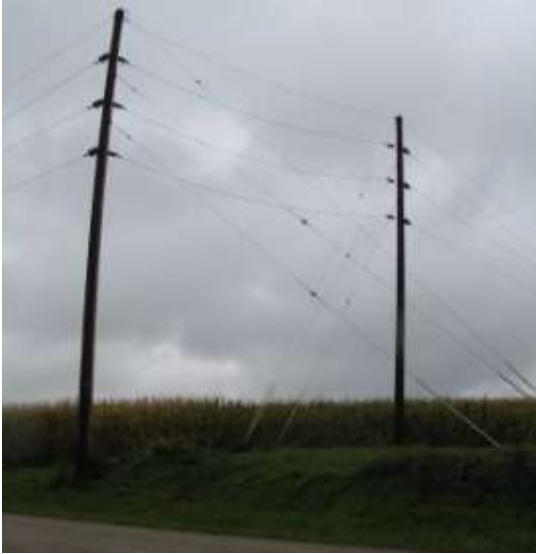
NESC 279 compliance issue possibly both poles

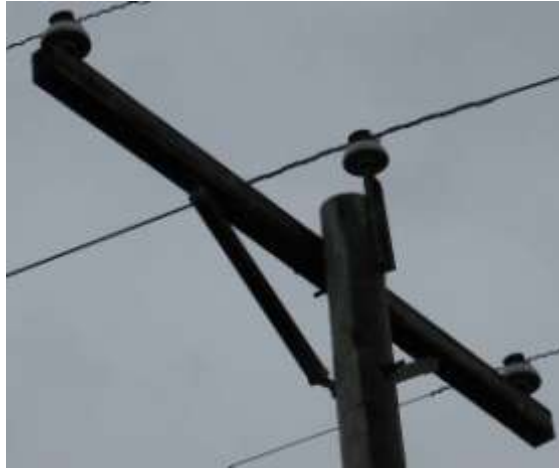
Twisted cross-arm

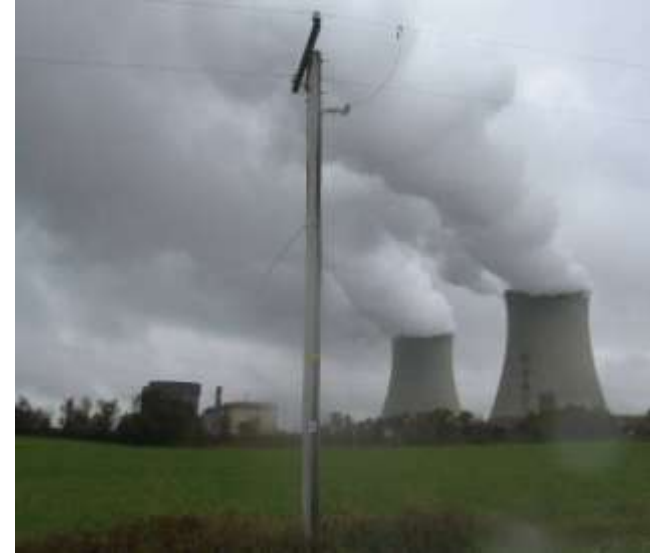
Ground wire molding hanging off pole

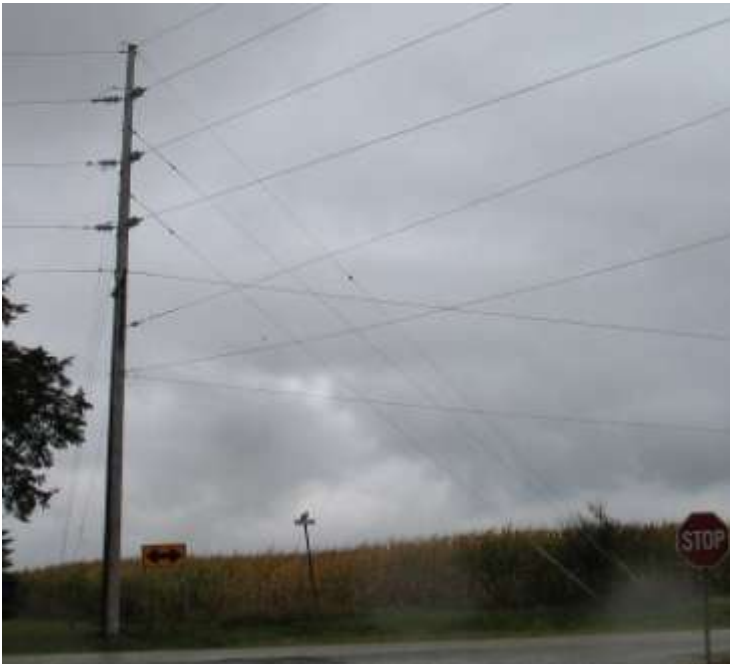
NESC 279 compliance issues

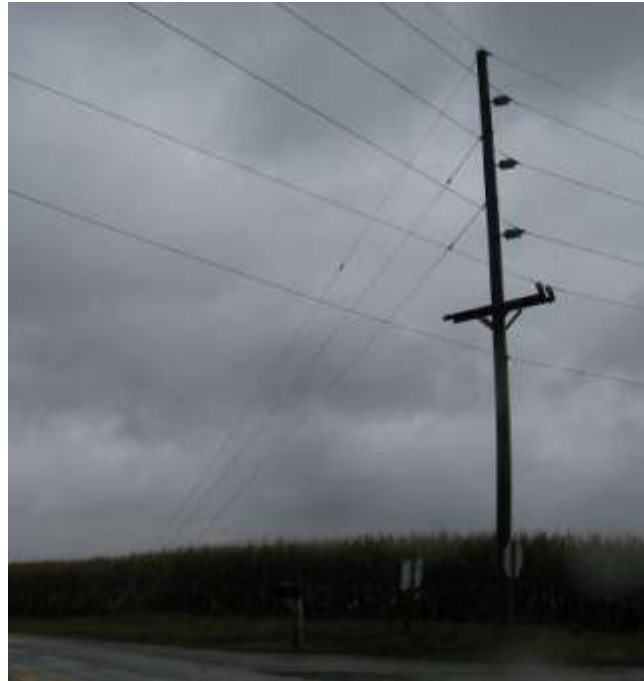
NESC 279 compliance issues
